**RE: Geotechnical Data Report for RFP Submittal
Twiggs Street from N. Meridian Avenue to Nebraska Avenue
Hillsborough County, Florida
Tierra Project No: 6511-16-107-013A**

Summary of Laboratory Test Results for Soil Classification
Twiggs Street from N. Meridian Avenue to Nebraska Avenue
Hillsborough County, Florida
Tierra Project No.: 6511-16-107-013A

**Representative Photographs of Pavement Cores
Twiggs Street from N. Meridian Avenue to Nebraska Avenue
Hillsborough County, Florida
Tierra Project No.: 6511-16-107-013A**

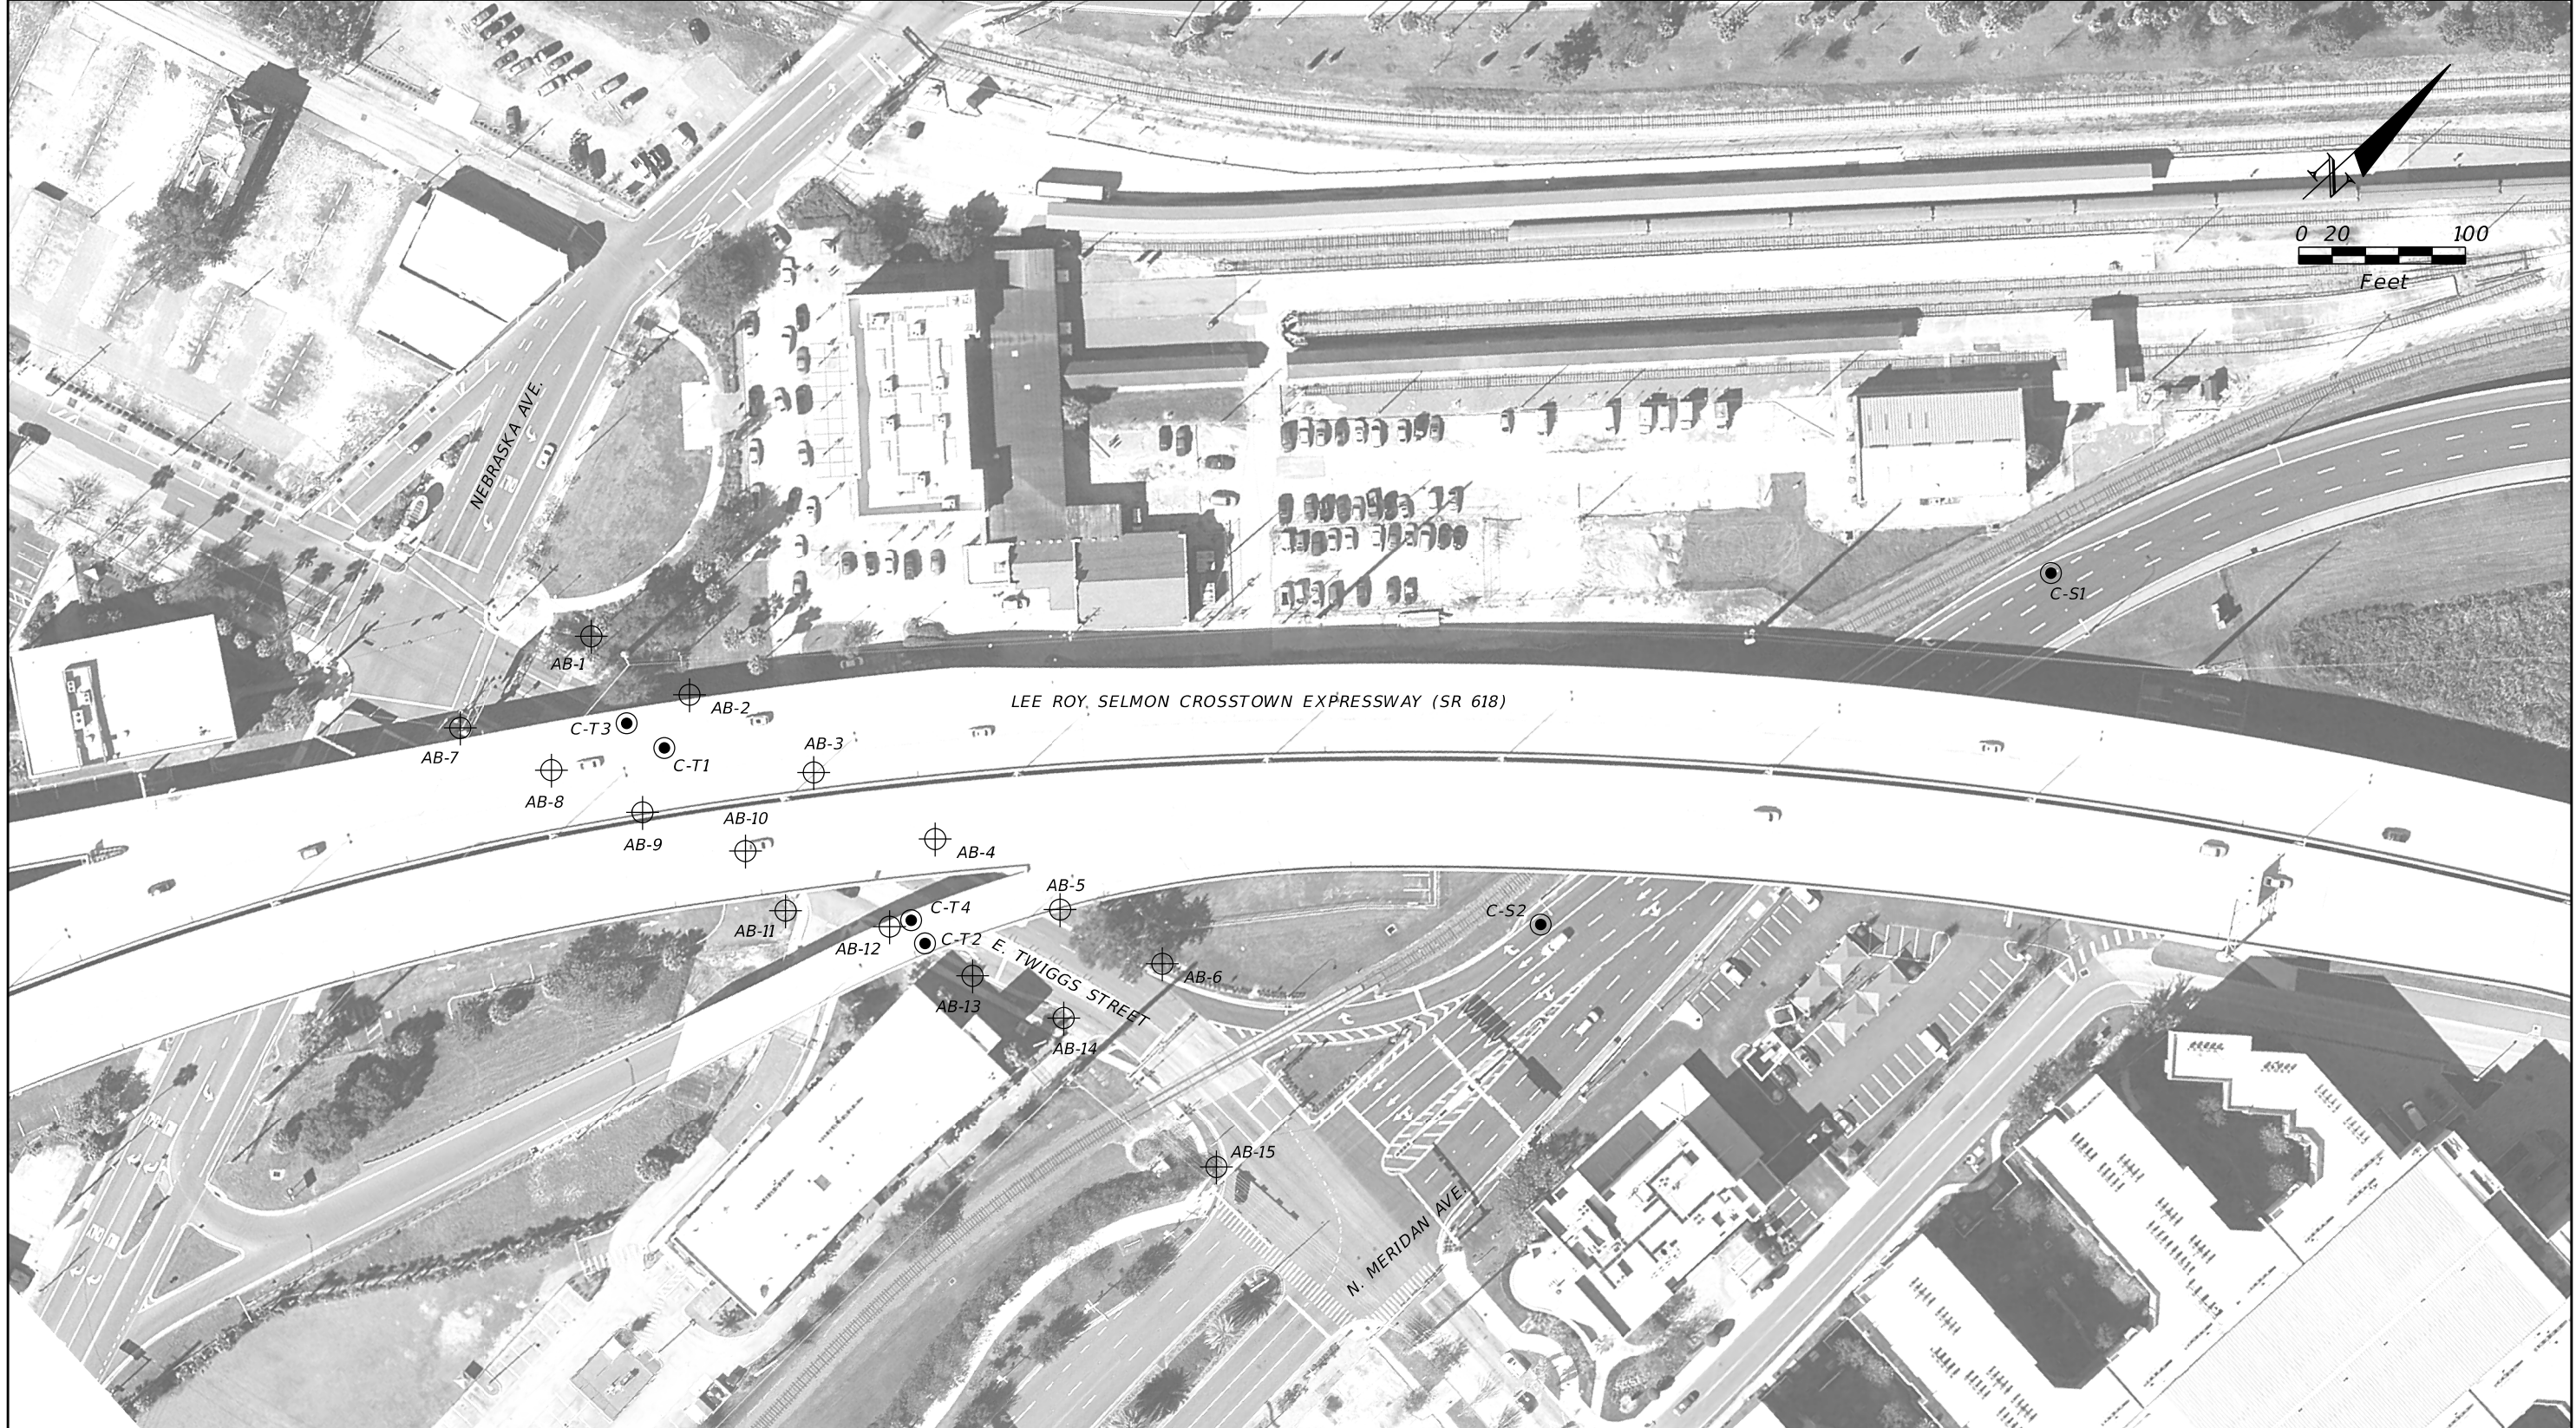
- APPROXIMATE CORE SAMPLE LOCATION
- ⊕ APPROXIMATE AUGER BORING LOCATION

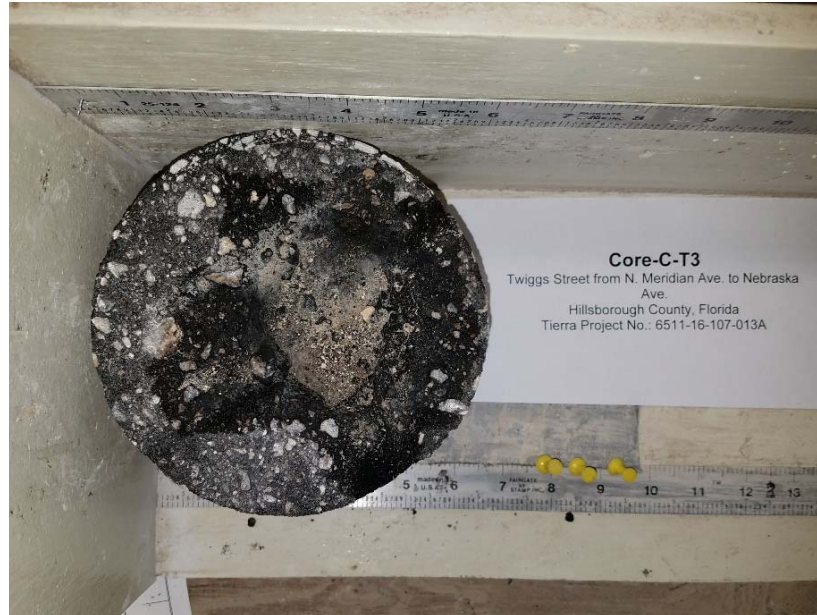
C-T3 Top View

C-T3	510728	1315528	1.5	2.1	---	S-1	Type III Leveling	---	3.6	Limerock	10.0	A-3 (Sand with Shell)	2.0	---	Poor	0.25	4.7	GNE
C-T4	510862	1315562	1.0	1.2	1.8	FC-9.5	SP-12.5	S-1	4.0	Limerock	9.5	A-3 (Sand with Shell)	2.0	4.0	Fair	N/A ⁽⁵⁾	1.4	GNE

The **Pavement Data Table** in **Appendix D** should be reviewed for specific information regarding the existing asphalt pavement and base materials encountered at each core location. Photographs of the pavement cores retrieved along the alignment are included in the attached **Representative Photographs of Pavement Cores** in **Appendix D**. It is important to note the base material thickness reported in the **Pavement Data Table** may not be reflected in the sample photographs due to sample break-up during recovery.
